Title: Fault detection in a centrifugal pump using vibration and motor current signature analysis

Kumar Pradhan, Prasanta & Ranjan Mohanty, Amiya & Nitaigour P, Mahalik & Ghosh Dastidar, Sabyasachi &. 2012. Fault detection in a centrifugal pump using vibration and motor current signature analysis. International Journal of Automation and Control. Volume 6, Nos. 3/4. ISSN 1740-7516 (electronic).

Fault detection in a centrifugal pump using vibration and motor current signature analysis

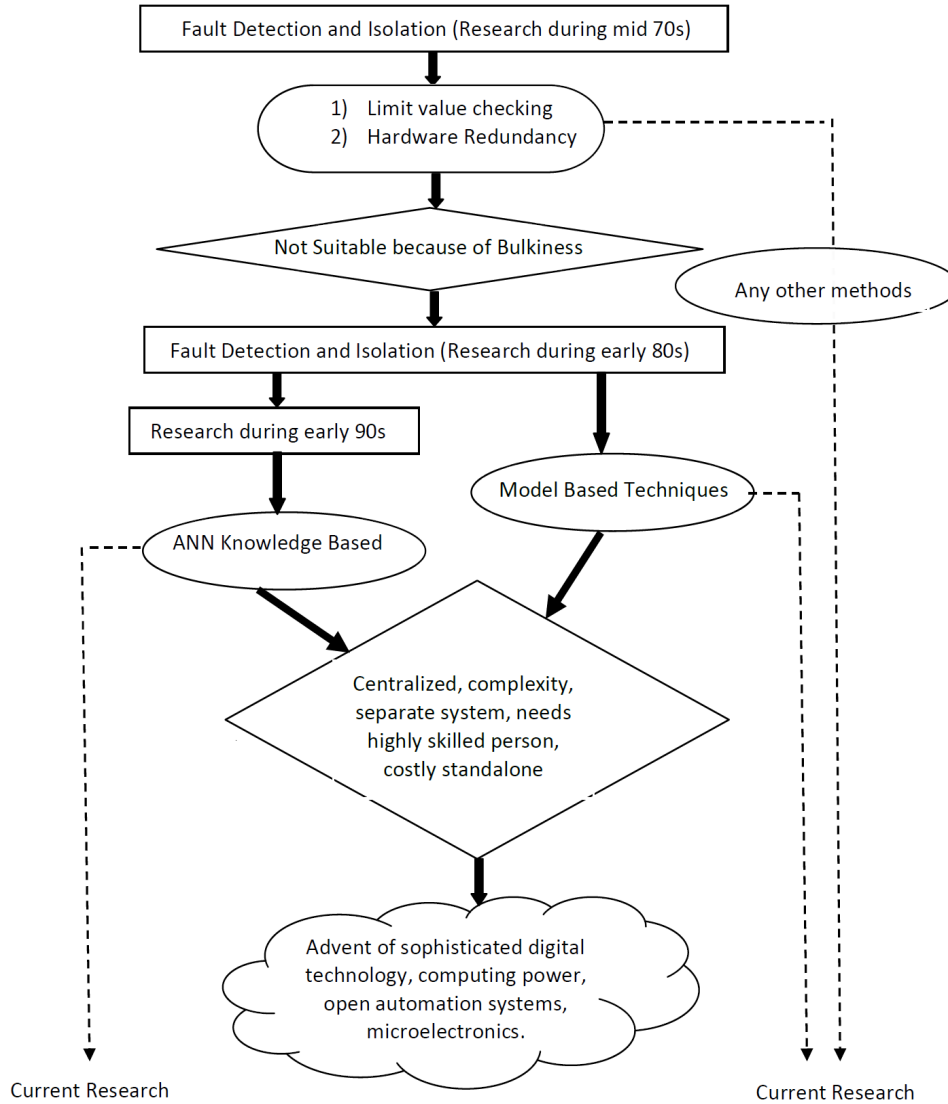
Figure 1 Progress on FDI

Next generation industrial systems will require more reliability, availability, safety, and embedded control strategy in response to provide highly customised products. The benefits that have been achieved so far through implementation of condition monitoring are now being significantly extended through the application of new theories, techniques, tools, and methods. Advances in computing tools and techniques have stimulated studies to design as well as realise autonomous machinery systems. Fault detection and isolation (FDI) is the main research topic that fall under the category of condition monitoring (Mohanty and Mahalik, 2007, 2011). Figure 1 (Mahalik et al., 1998) illustrates the progress on condition monitoring methods.

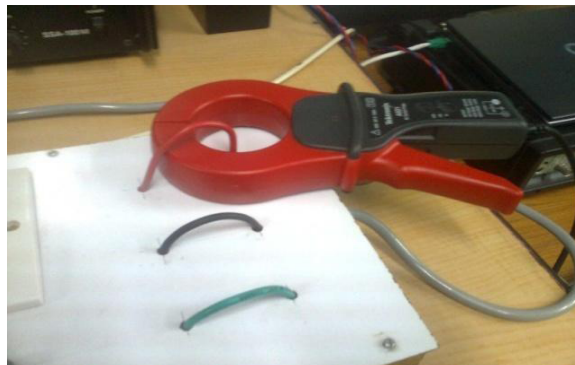
Figure 3 Hall effect sensor (see online version for colours)

The accelerometer (PCB 353B33) was placed on the casing of the pump close to the bearing (as shown in Figure 2) to measure the vibration. Hall effect sensor (Tektronix A621, as shown in Figure 3) was kept around the phase terminal of motor current to measure the instantaneous motor current. The centrifugal pump (0.75 kW, 1,450 RPM, 240 V, make-Crompton Greaves, as shown in Figure 2) was operated under different working conditions of impeller like normal impeller (all vanes present), one vane broken impeller, two vanes broken impeller, three vanes broken impeller (as shown from Figures 4 to 8) sequentially.

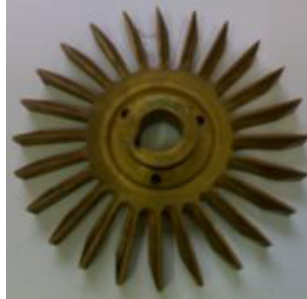
Figure 4 Normal impeller (see online version for colours)

Specification of the impellers used in pump is made of brass; with external diameter 100 mm; width 10 mm; vane length 25 mm and number of vanes are 24. The diameter of impeller hub is 13 mm. The experimental work has been performed in the following sequence:

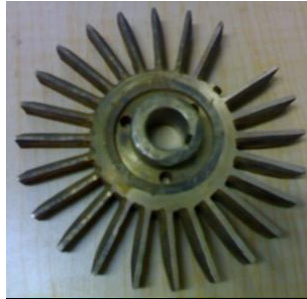
Figure 5 Broken impeller (one vane missing) (see online version for colours)

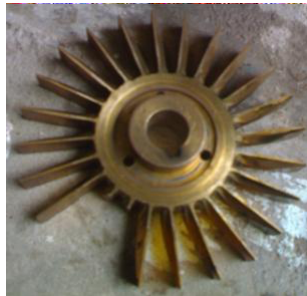
Figure 6 Broken impeller (two vane missing) (see online version for colours)

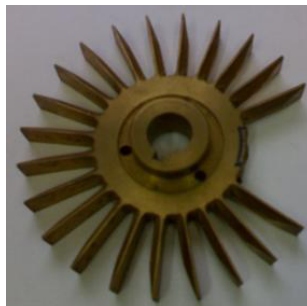
Figure 7 Broken impeller (three vane missing) (see online version for colours)

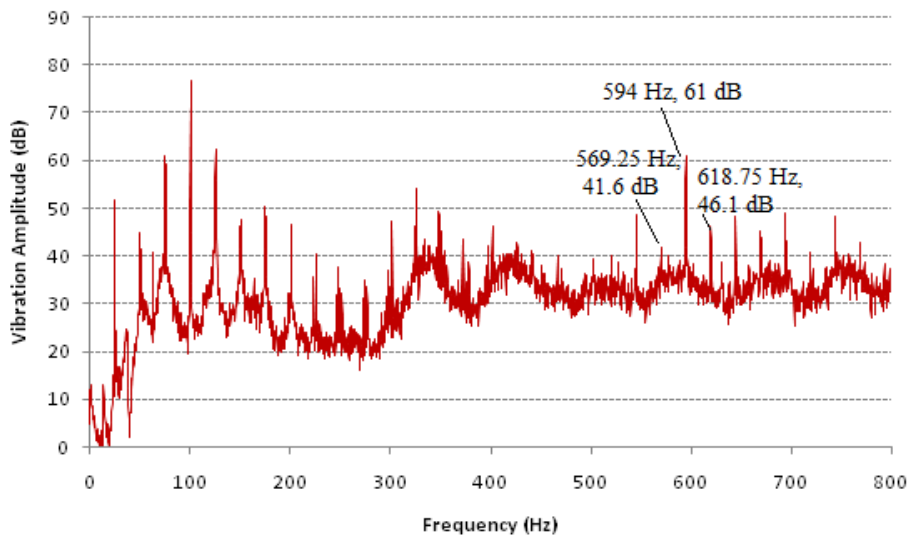
Figure 9 Vibration spectra of the normal impeller (see online version for colours)

From the vibration spectra it has been observed that the first high peak was at 24.75 Hz (52 dB) which happens to be the rotational speed (RPS) of the pump. This measurement was verified by an optical tachometer which indicated a rotational speed of 1,485 RPM. Also, the presence of VPF (i.e., $RPS \times \text{No. of vanes}$) was observed in the vibration spectra. Their corresponding amplitudes (in dB) and their SBs (at $VPF \pm RPS$) for different impellers were noticed. The observations of vibration spectra (as shown in Figures 9 to 12) for different impellers are summarised in Table 2.

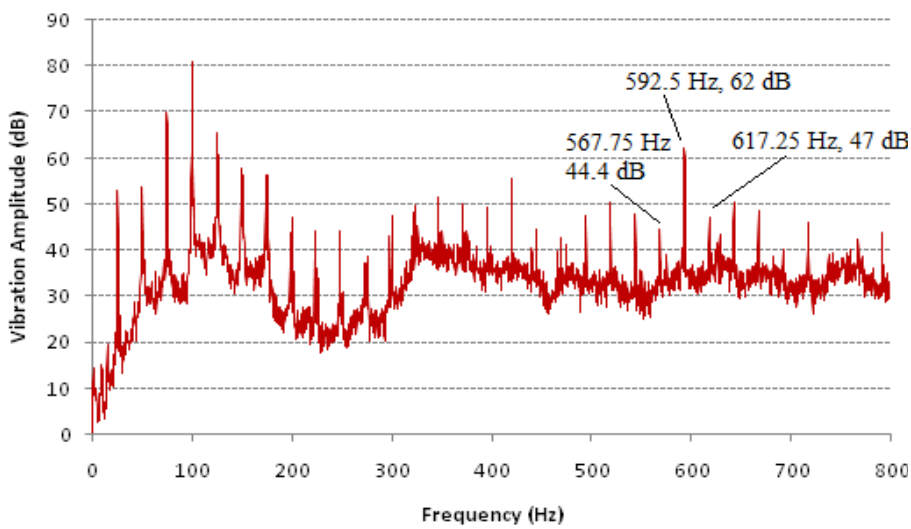
Figure 10 Vibration spectra of the defective impeller (with one vane missing) (see online version for colours)
